# Report

Incident on **2 May 2009**  
**on approach to Antalya (Turkey)**  
to the **Boeing 737-300**  
registered **F-GFUF**  
operated by **Europe Airpost**

**BEA**

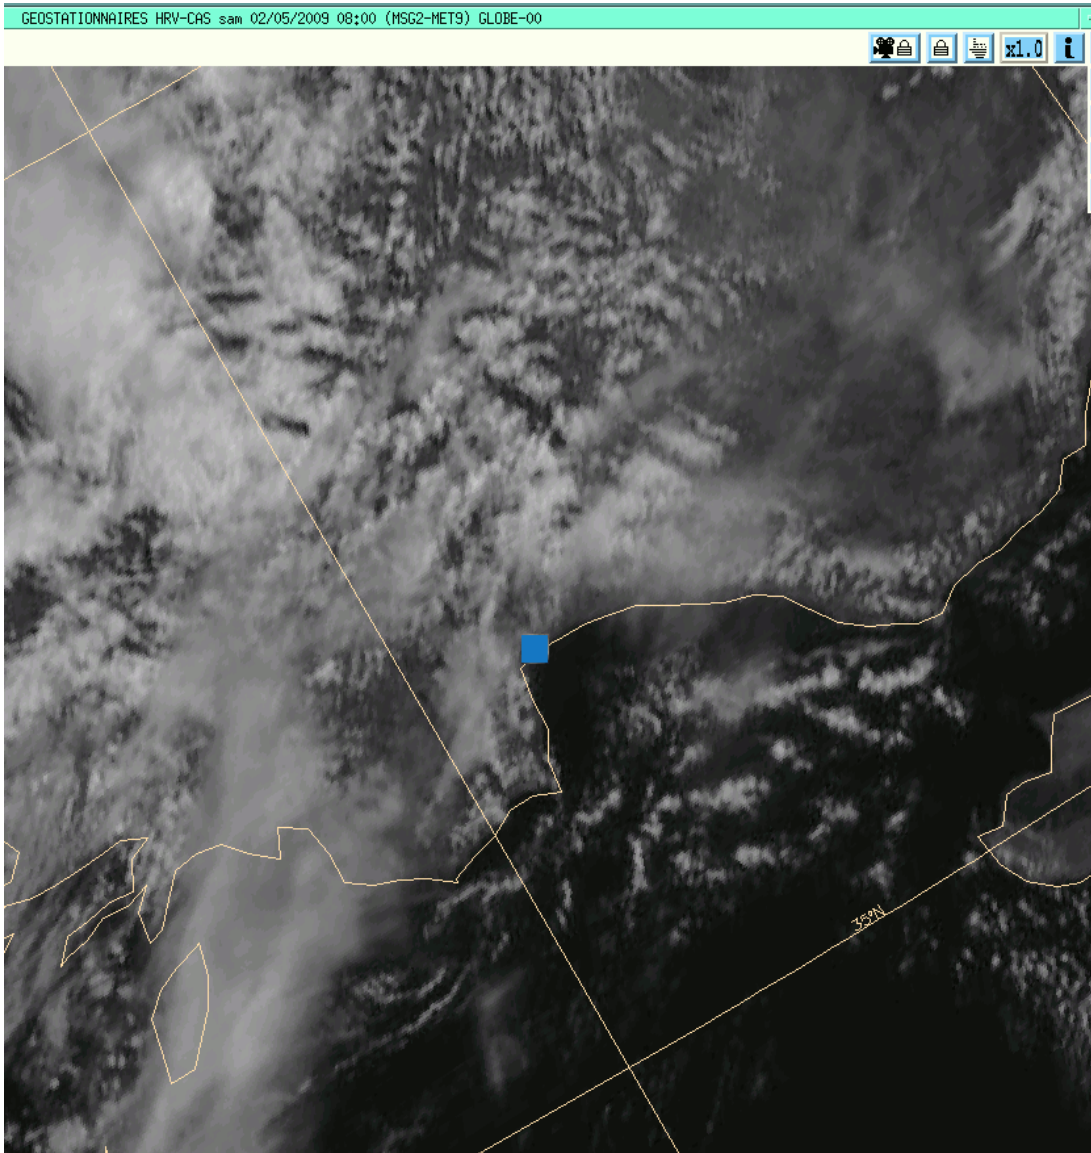
## Satellite image at 7 h 00 UTC

<b>Events:</b>	Temporary loss of control, stall with AP and A/T
<b>Consequences and damage:</b>	No damage
<b>Aircraft:</b>	Boeing 737- 300
<b>Date and time:</b>	2 May 2009 at 7 h 13 UTC <sup>(1)</sup>
<b>Operator:</b>	Europe Airpost
<b>Place:</b>	On approach at about 30 NM north of Antalya (Turkey)
<b>Type of flight:</b>	Public transport of passengers (charter flight)
<b>Persons on board:</b>	2 flight crew - 3 cabin crew - 110 passengers
<b>Meteorological conditions in the event area:</b>	The satellite <sup>(2)</sup> image shows a steady south-westerly flow as well as the presence of mountain waves

<sup>(2)</sup>The crew did not possess this image. The meteorological file at its disposal did not make it possible to identify a mountain wave phenomenon. The satellite image is shown in Appendix.
